TEST REPORT

ASTM E330

REPORT NO.: 11123.01-106-11

PRODUCT TYPE: Brick Rainscreen System (without mortar)

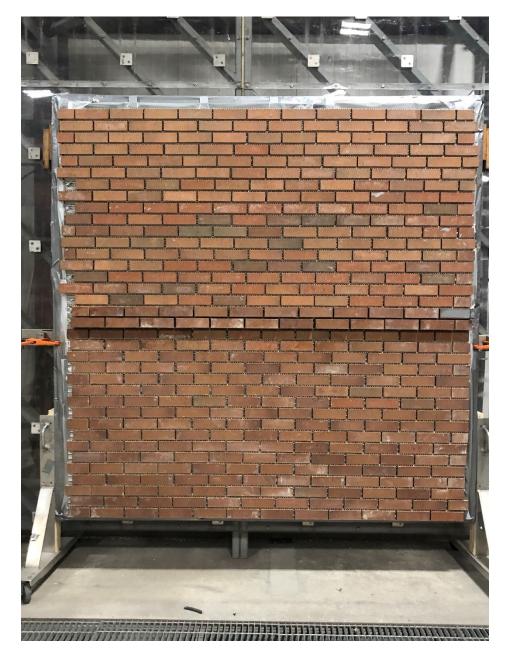
Photograph

Brick Rainscreen System (without mortar)
